SUBJECT: Agenda Item 2A – 04/06/2022 Board Meeting
Station 15 Building Condition Assessment Final Report

**LOS OSOS COMMUNITY SERVICES DISTRICT
FIRE STATION 15
CONDITIONS ASSESSMENT**

The Los Osos Community Services District sought to obtain a building condition assessment report for the District's Fire Station No. 15 to determine the physical adequacy of the primary facility in the short term and long term future, and recommendations for improvement over a 10 year period of time.

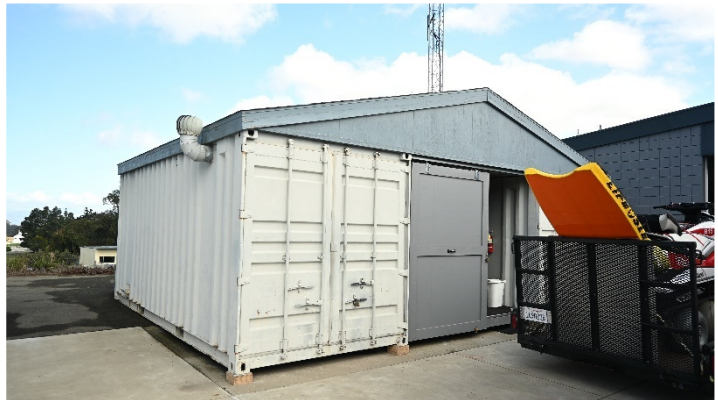
Two C-Trains with Roof Spanning Space for Workshop

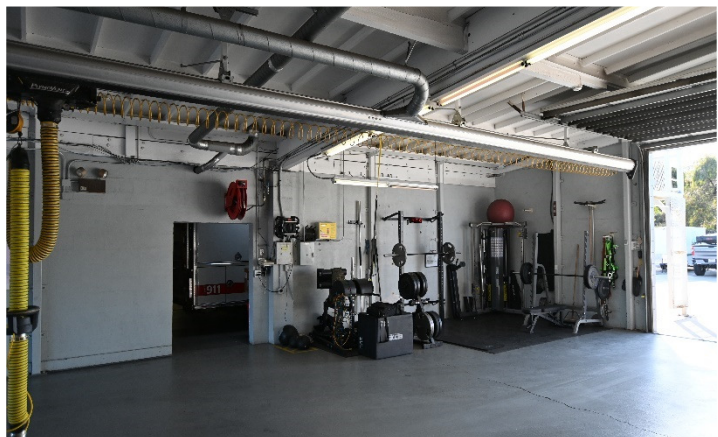
Supplemental Exercise Area in Apparatus Bay

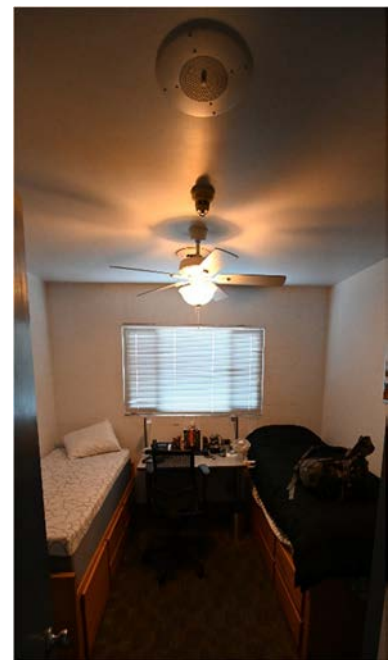
- The dorm rooms lack emergency egress windows. This is a code deficiency that is not required to be addressed, but can threaten Life/Safety should there be a fire in the Fire Station that prevents the occupants of the dorm rooms to exit.
- There are no person doors from the Apparatus Bay to the outside. The only way to exit is by opening the overhead doors or going through the administration area or living quarters. This is a code deficiency that threatens Life/Safety.

Dorm Room Windows are not Sized for Emergency Exiting

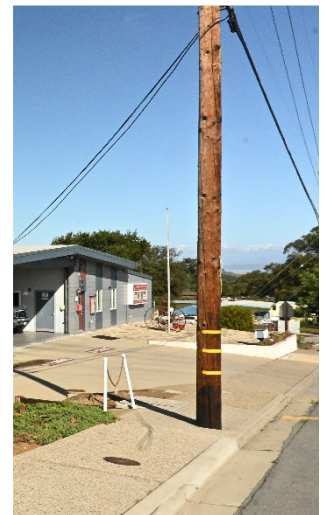
- Power Lines in Front of Apparatus Bay: The overhead lines that run across the front of the fire station are concerning. If the power poles or overhead power lines fall down, this will hinder the fire trucks’ ability to exit the station.

Power Lines Span two Power Poles in Front of the Apparatus Bay

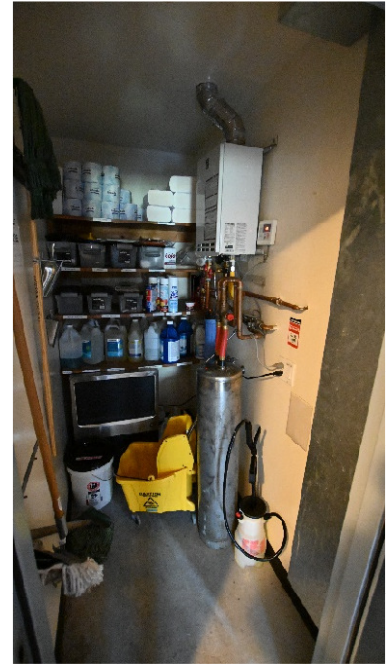
Under-sized Instant Wall-Mounted Water Heater
