**TO:** Emergency Services Advisory Committee  
**FROM:** Ron Munds, General Manager  
**SUBJECT:** Agenda Item 3 – 05/18/2023 ESAC Meeting  
Station 15 Building Condition Assessment Final Report

**LOS OSOS COMMUNITY SERVICES DISTRICT  
FIRE STATION 15  
CONDITIONS ASSESSMENT**

# LOCSO FIRE STATION 15 DRAFT CONDITIONS ASSESSMENT

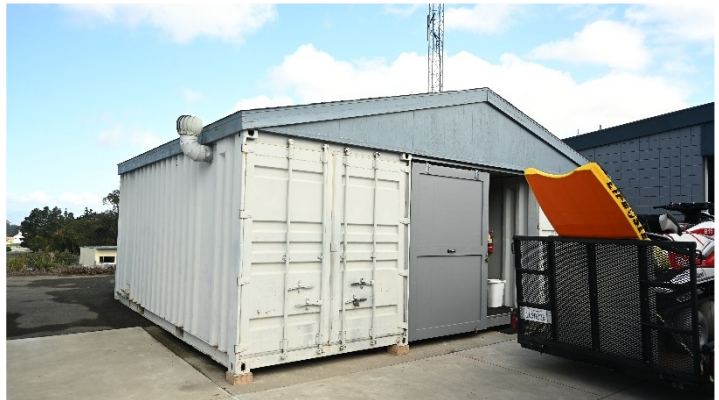
Two C-Trains with Roof Spanning Space for Workshop

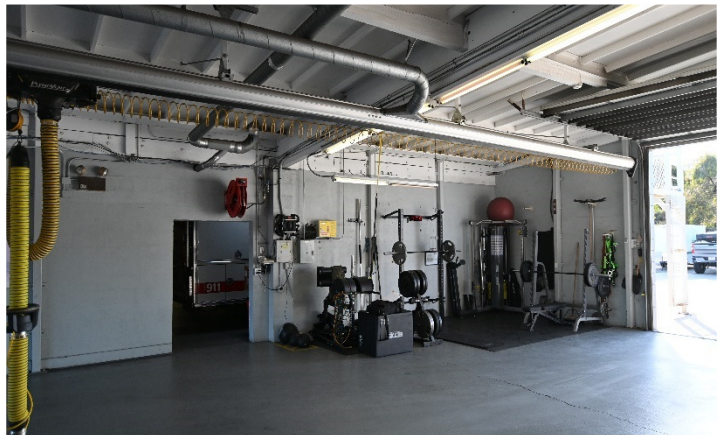
Supplemental Exercise Area in Apparatus Bay

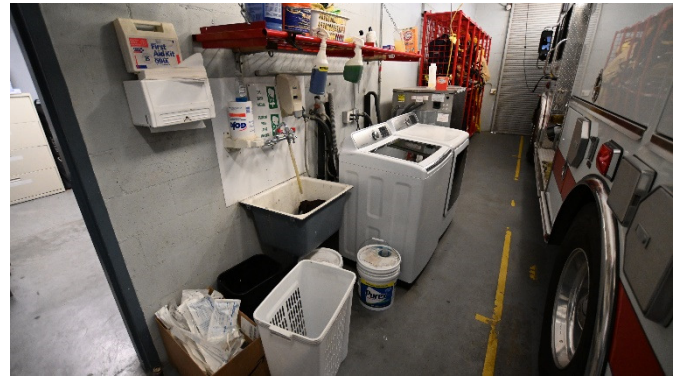
- Washers and dryers used for personnel uniforms and linens are located next to the Apparatus Bay, exposed to vehicle exhaust and other toxins.

**Washer and Dryer in Apparatus Bay**

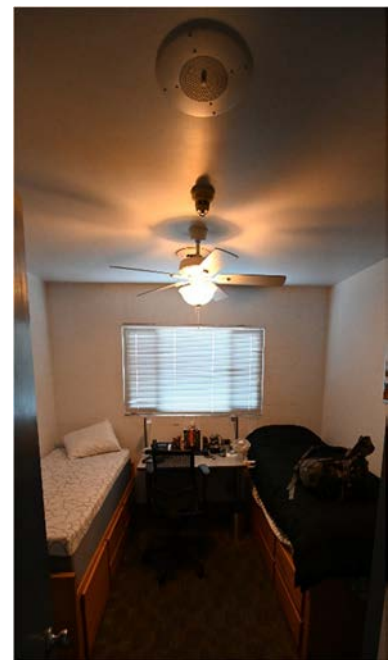
- The dorm rooms lack emergency egress windows. This is a code deficiency that is not required to be addressed, but can threaten Life/Safety should there be a fire in the Fire Station that prevents the occupants of the dorm rooms to exit.
- There are no person doors from the Apparatus Bay to the outside. The only way to exit is by opening the overhead doors or going through the administration area or living quarters. This is a code deficiency that threatens Life/Safety.

**Dorm Room Windows are not Sized for Emergency Exiting**

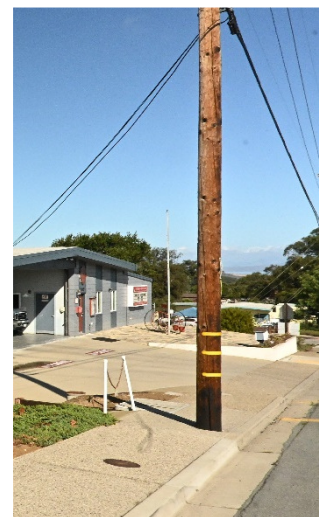
- Power Lines in Front of Apparatus Bay: The overhead lines that run across the front of the fire station are concerning. If the power poles or overhead power lines fall down, this will hinder the fire trucks’ ability to exit the station.

**Power Lines Span two Power Poles in Front of the Apparatus Bay**

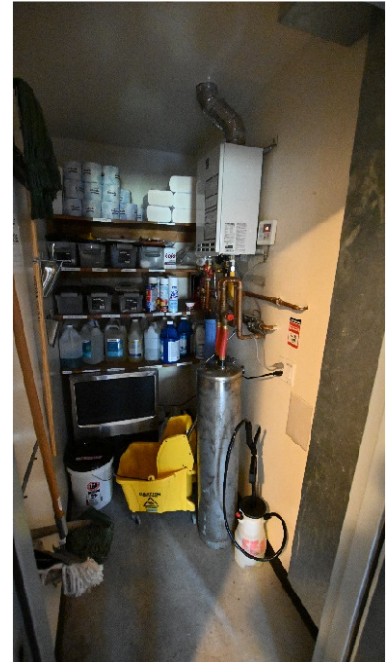
**Under-sized Instant Wall-Mounted Water Heater**

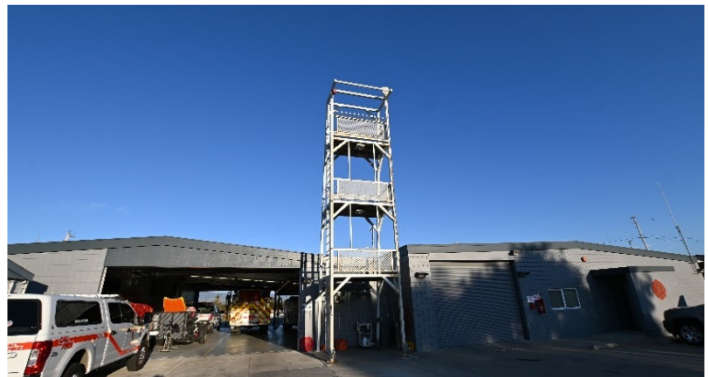
**Existing Hose Drying Tower at the back of the Apparatus Bay**

- Reconstruct transition at driveway approach and roadway intersection to reduce dip.
- Remove or relocate the existing hose tower for better vehicle maneuverability and to create access for a second folding door at the rear of the Apparatus Bay. Also, the hose drying tower is awkward to use. Replace the hose-drying tower with horizontal hose drying racks at a different location.
- Replace Generator to accommodate additional loads from new building.
