UTILITIES ADVISORY COMMITTEE MEETING

Leak Detection Services Project Summary

Project: Los Osos, CA 2019 Leak Detection Report

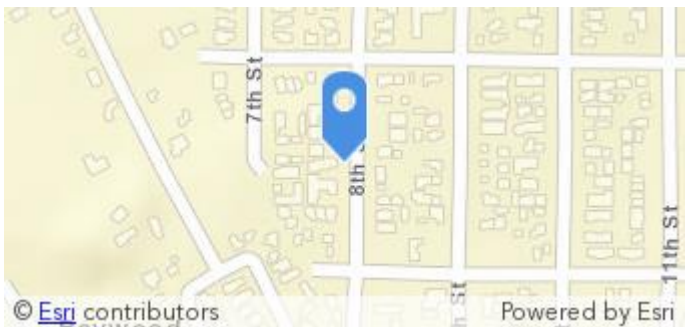
| <p>Meter 17810202 Elevated noise detected on service. Visible water appears to be leaking from curb stop and/or inlet meter nut in box. Noise remained after isolation possibly due to leakage at curbstop.</p> | | | | | | | | | |

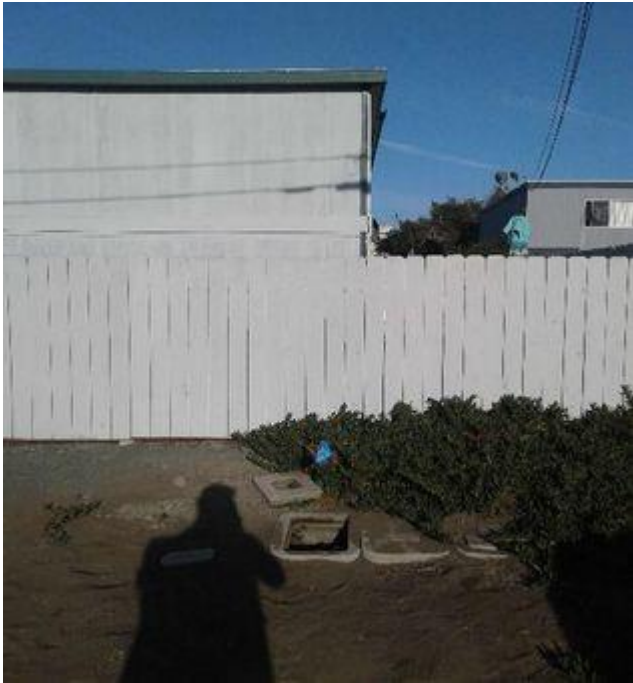
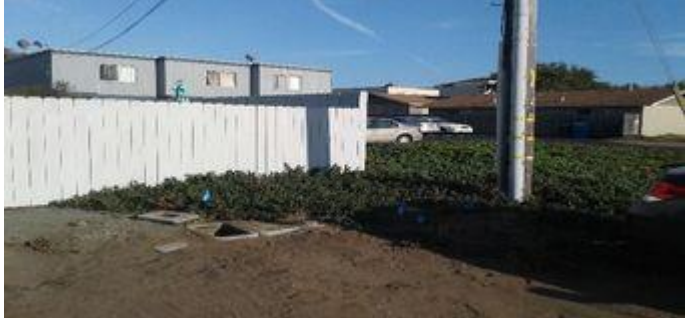
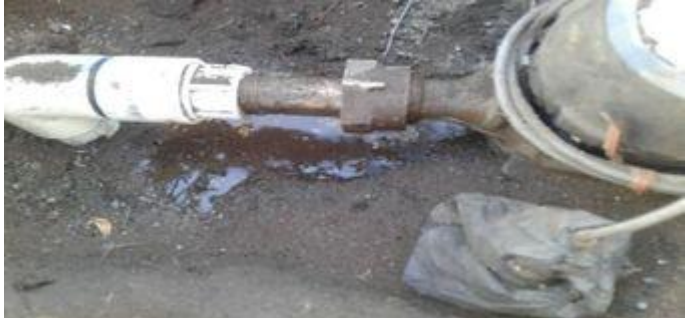
| <p>Meter 14161296 Elevated noise detected on service. Noise dissipated following shut off. Visible water appears to be leaking from outlet meter nut in box.</p> | | | | | | | | | |

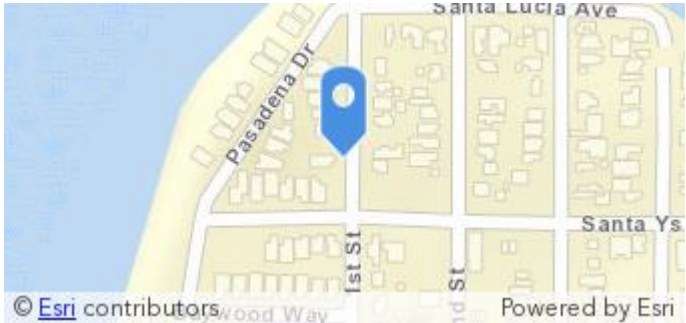
| Faint noise detected on Meter 16681543, noise remained following shut off. Correlations results inconclusive. No ground noise observed. No elevated noise present on surrounding connections. | | | | | | | | | |

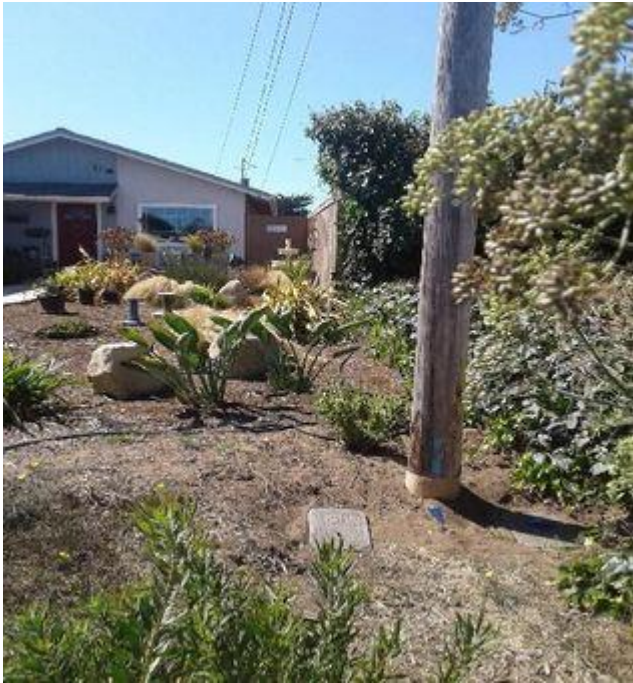
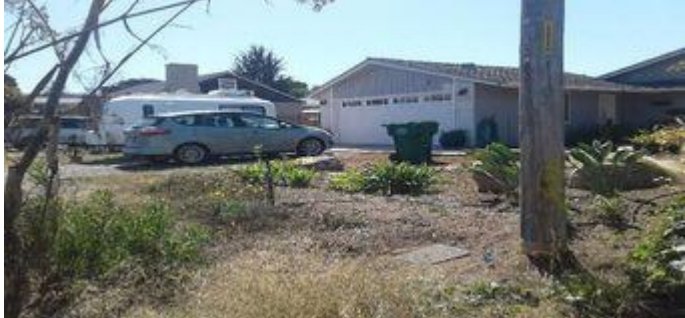
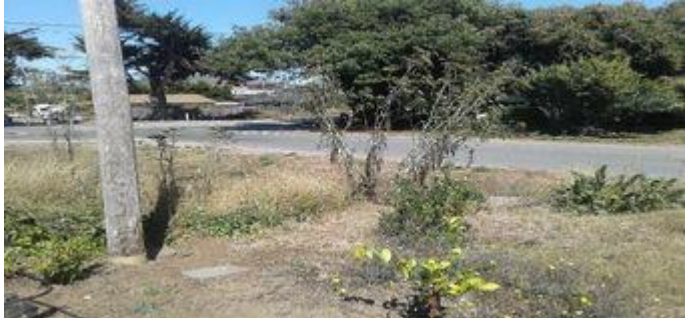
| Leak Description & Comments: <p>Elevated noise detected on Meter 17046424 , noise present following shut off. However, curbstop begins to leak when placed in "off" position. Recommend excavating near meter boxes an pulling service.</p> | | | | | | | | | |

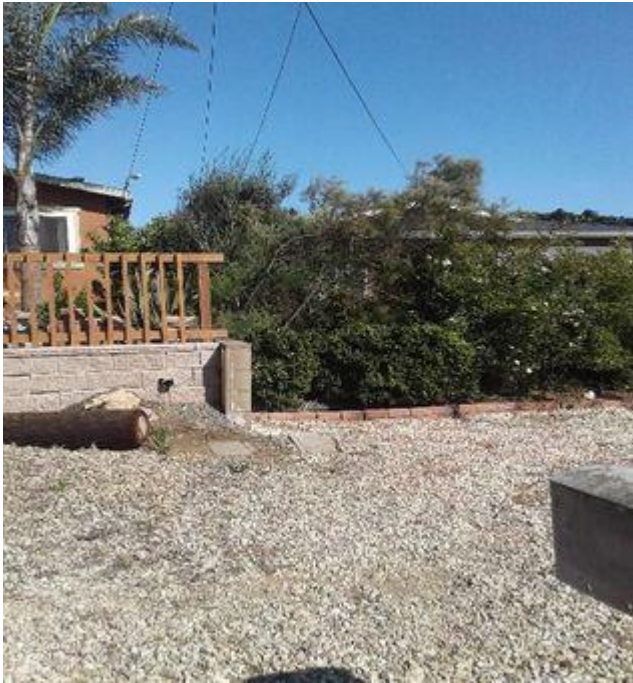
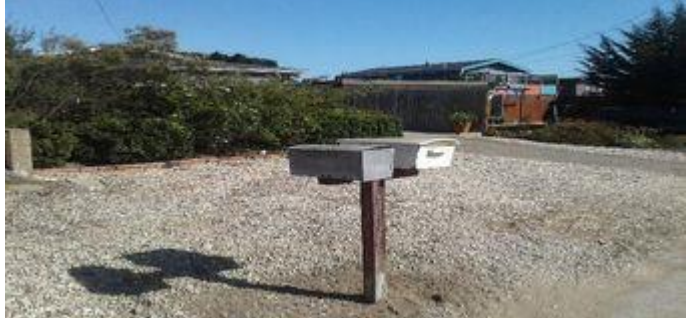
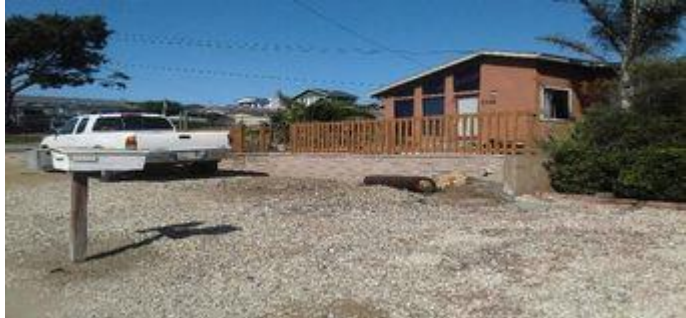
| Leak Description & Comments: Elevated noise detected on Meter 18183319, noise remained following shut off. Recommend excavating at meter box and pulling service. Both meters also appears to have customer side leakage present. | | | | | | | | | |
