**SUBJECT:** **Agenda Item 5G – February 6, 2020 Board Meeting**  
Summary of the January 21, 2020 Parks & Rec Meeting

# LOS OSOS DOG PARK - CONCEPT PLAN

# Morro Shoulderband Snail Habitat Assessment and Protocol Survey Results Report for Ferrell Street Footpath Improvement Project (074-251-006), Los Osos, San Luis Obispo County, California

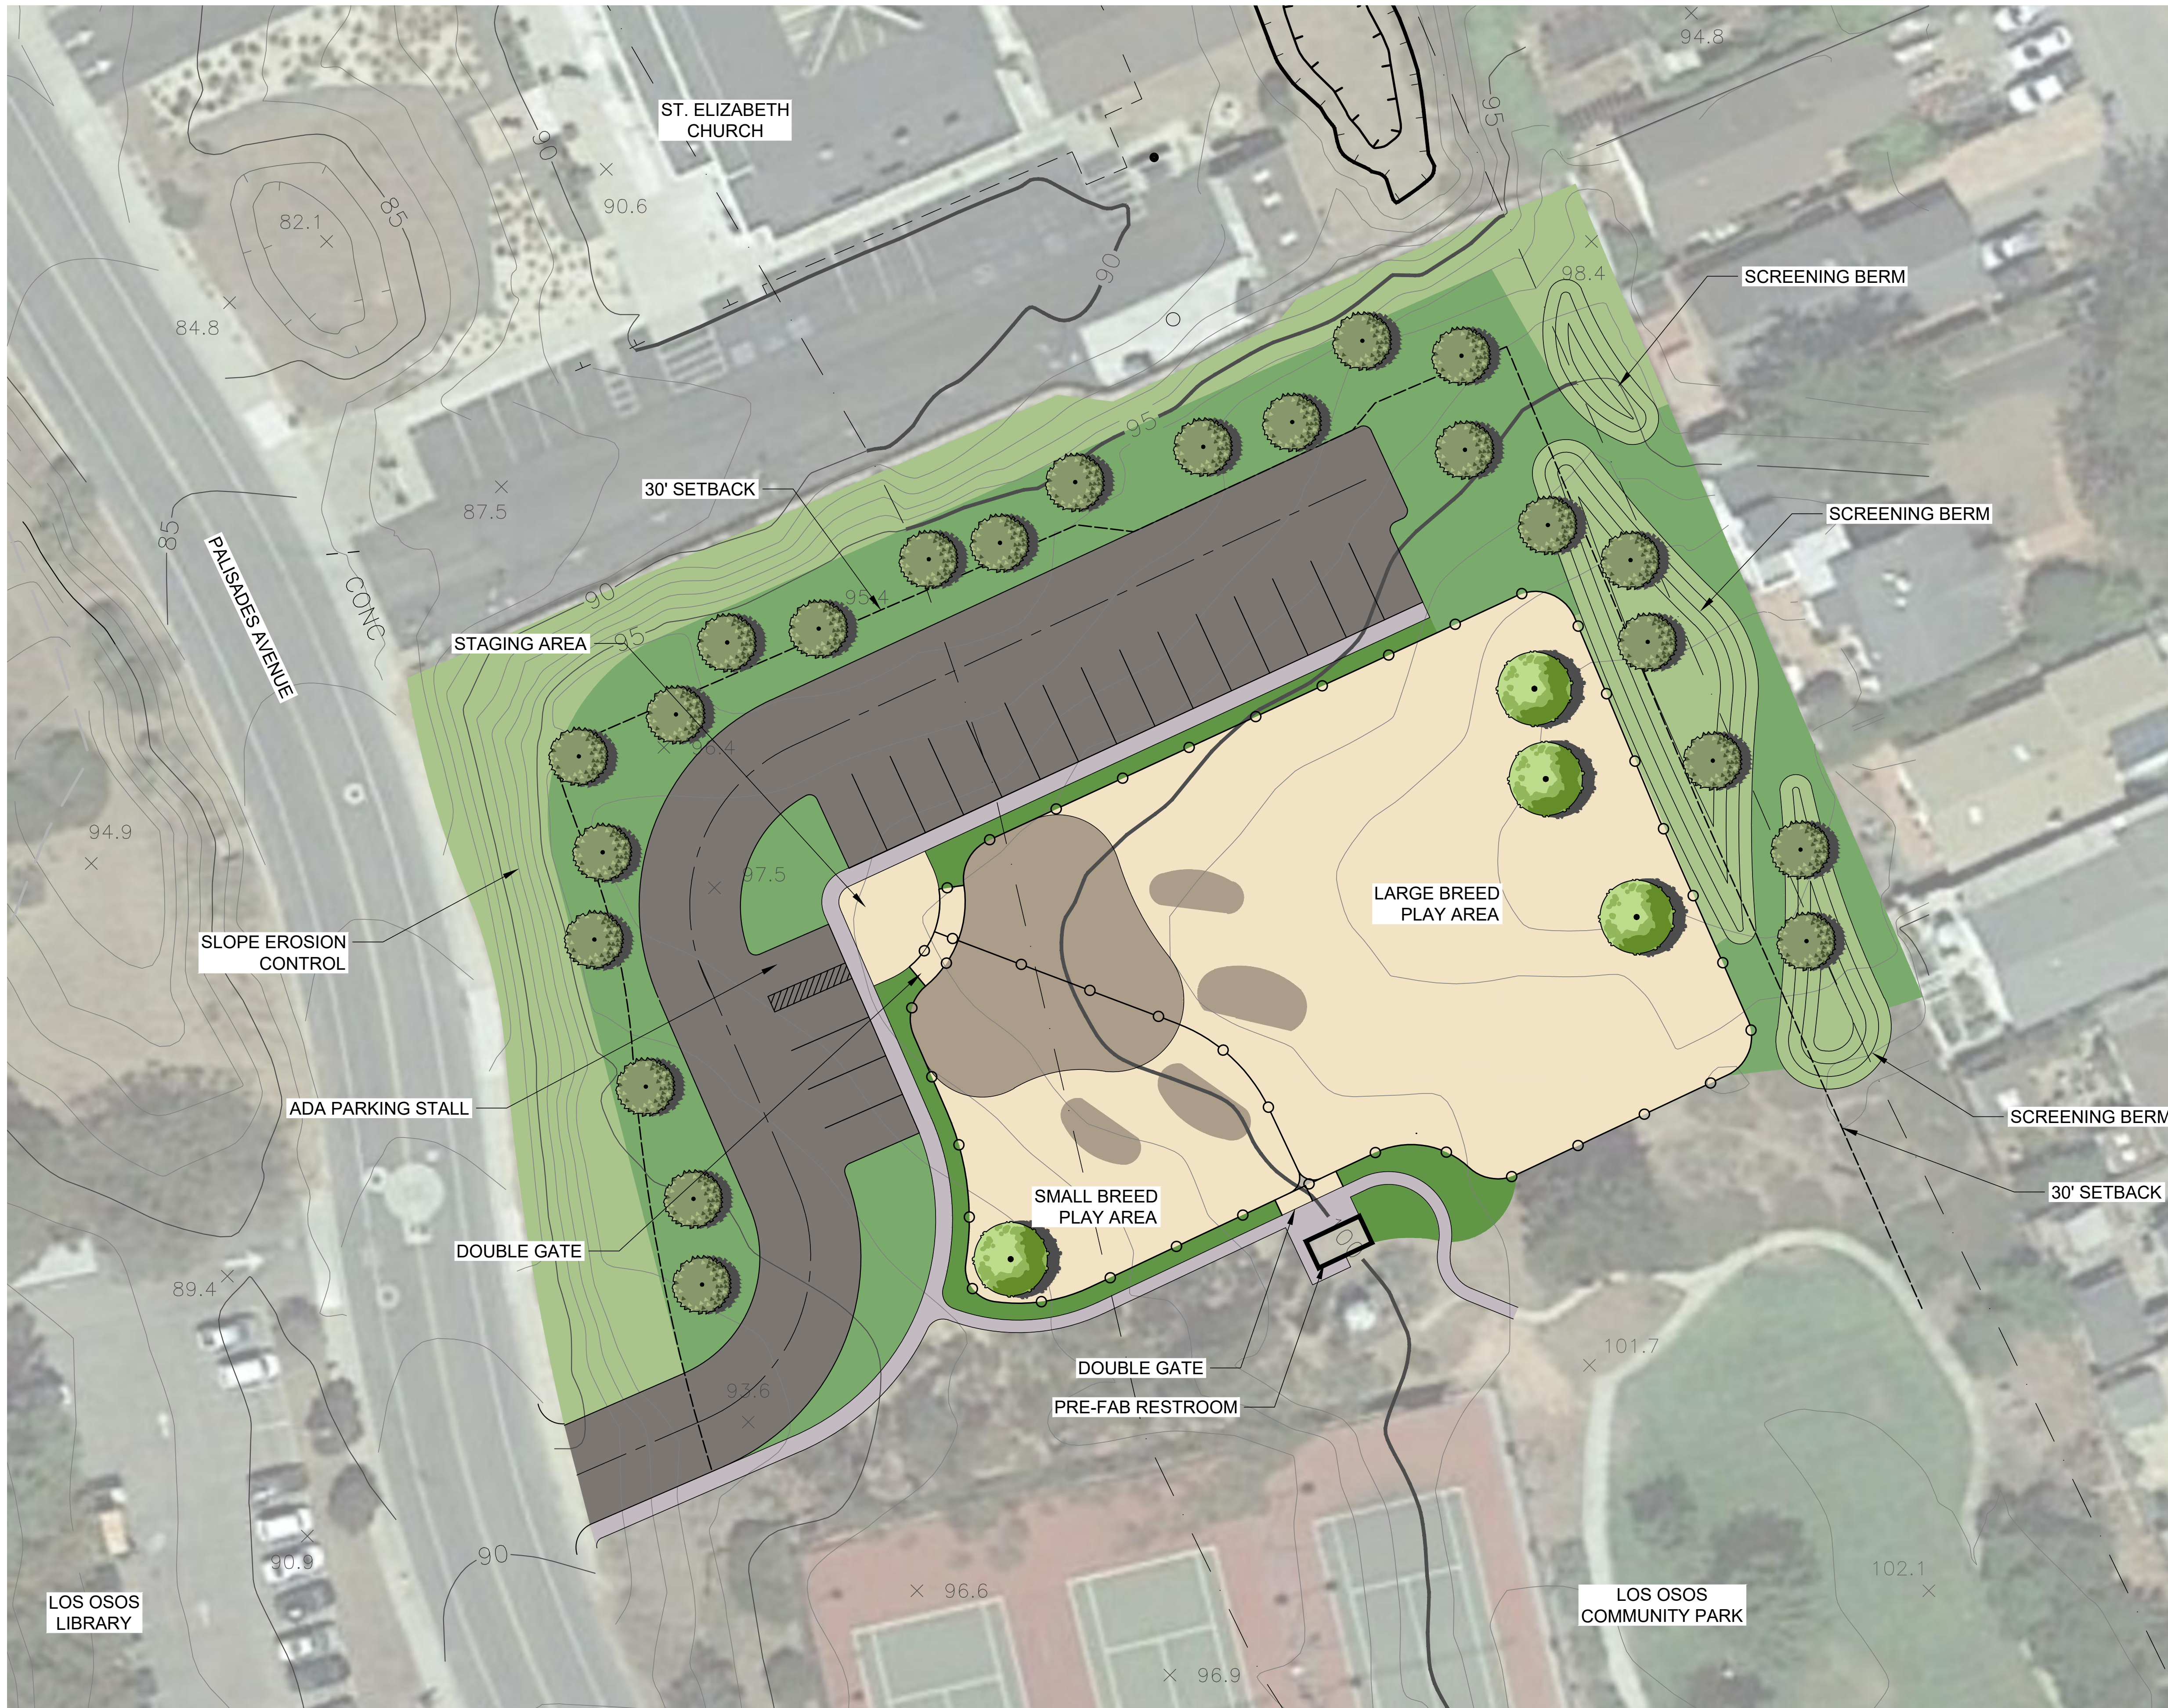
**APN 074-229-027**

AREA OF DISTURBANCE: 66,377 SF

IMPERVIOUS AREA: 15,219 SF

DOG PARK AREA: 20,670 SF

LARGE BREED AREA: 15,536 SF

SMALL BREED AREA: 4,919 SF

The Dog Park concept plan was presented. Input from the committee and public is requested. Concept plan on the website with comment form.

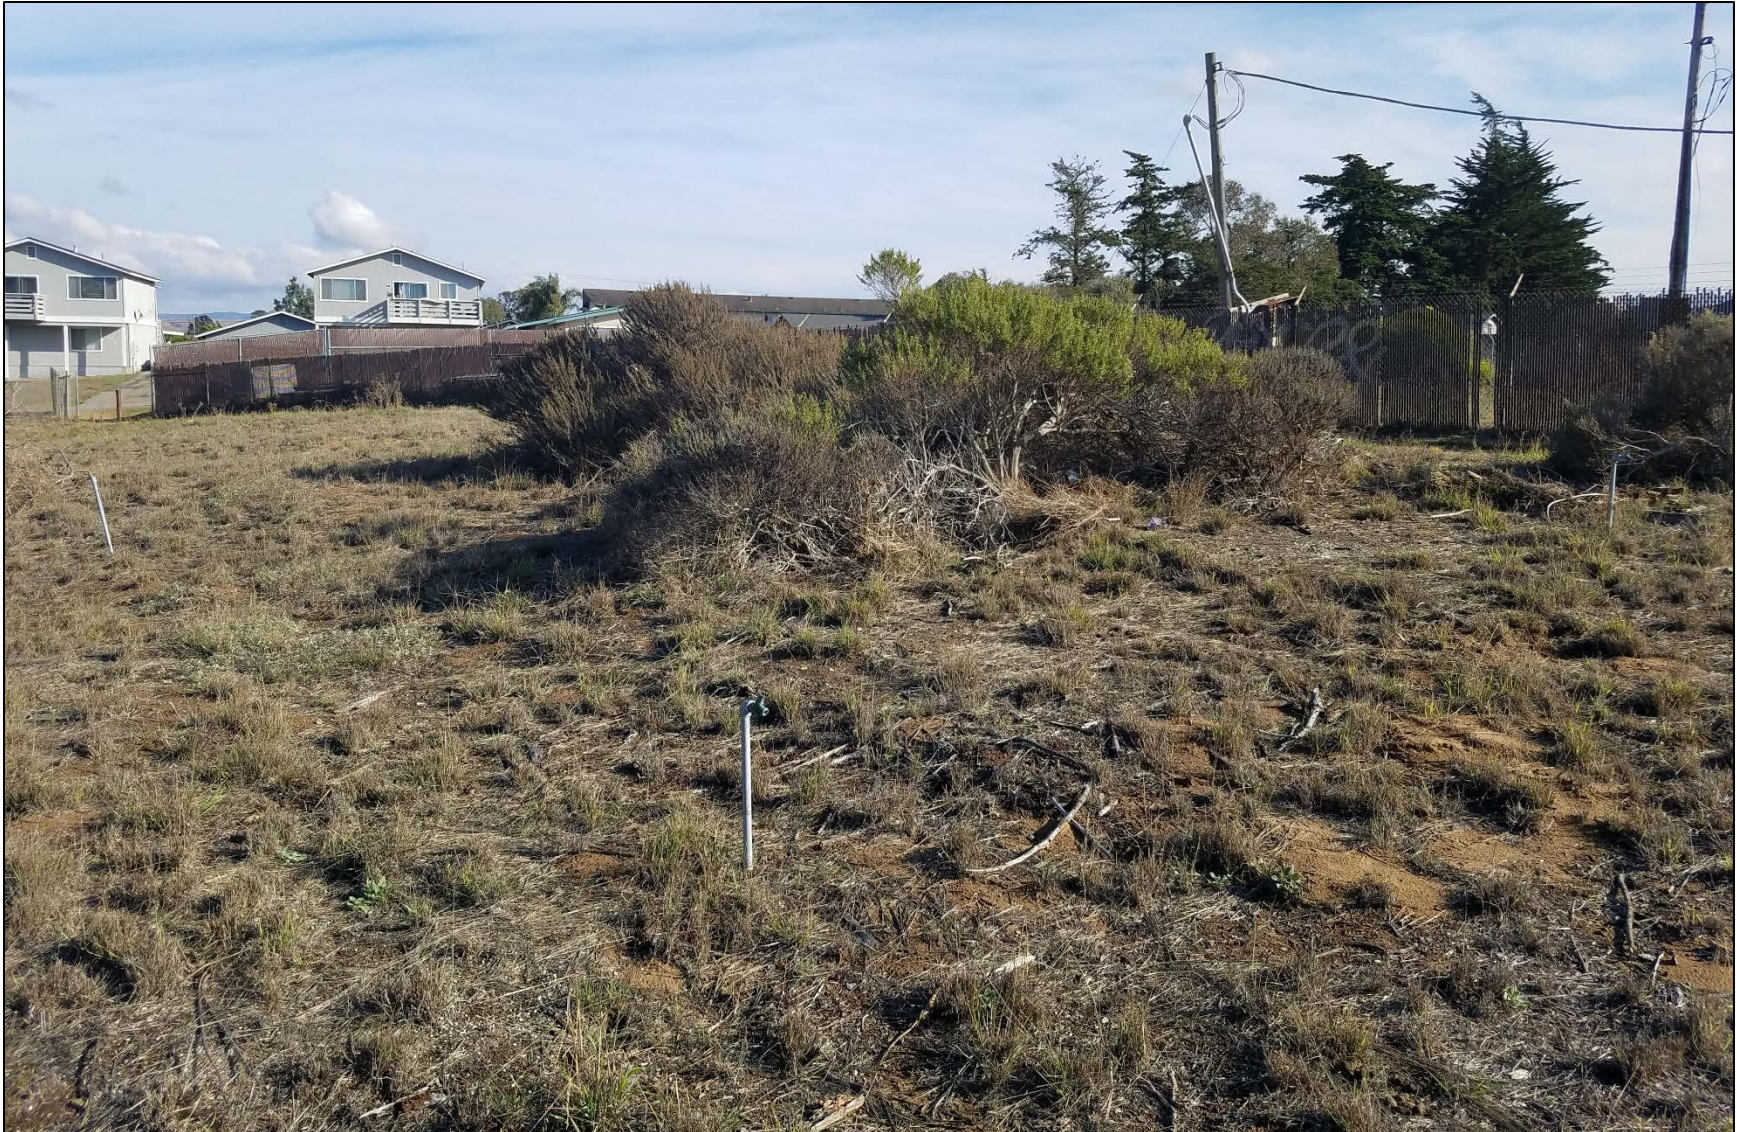
**Photo 1:** Photo viewing east of location where live MSS were observed during the focused survey efforts.

Two live and active adult MSS were observed within the remnant coastal scrub habitat present within the survey area. Specifically, one MSS was observed under a coyote brush (*Baccharis pilularis*) and the other under a black sage (*Salvia mellifera*). No empty MSS shells and no other species of snail was observed during the survey efforts.

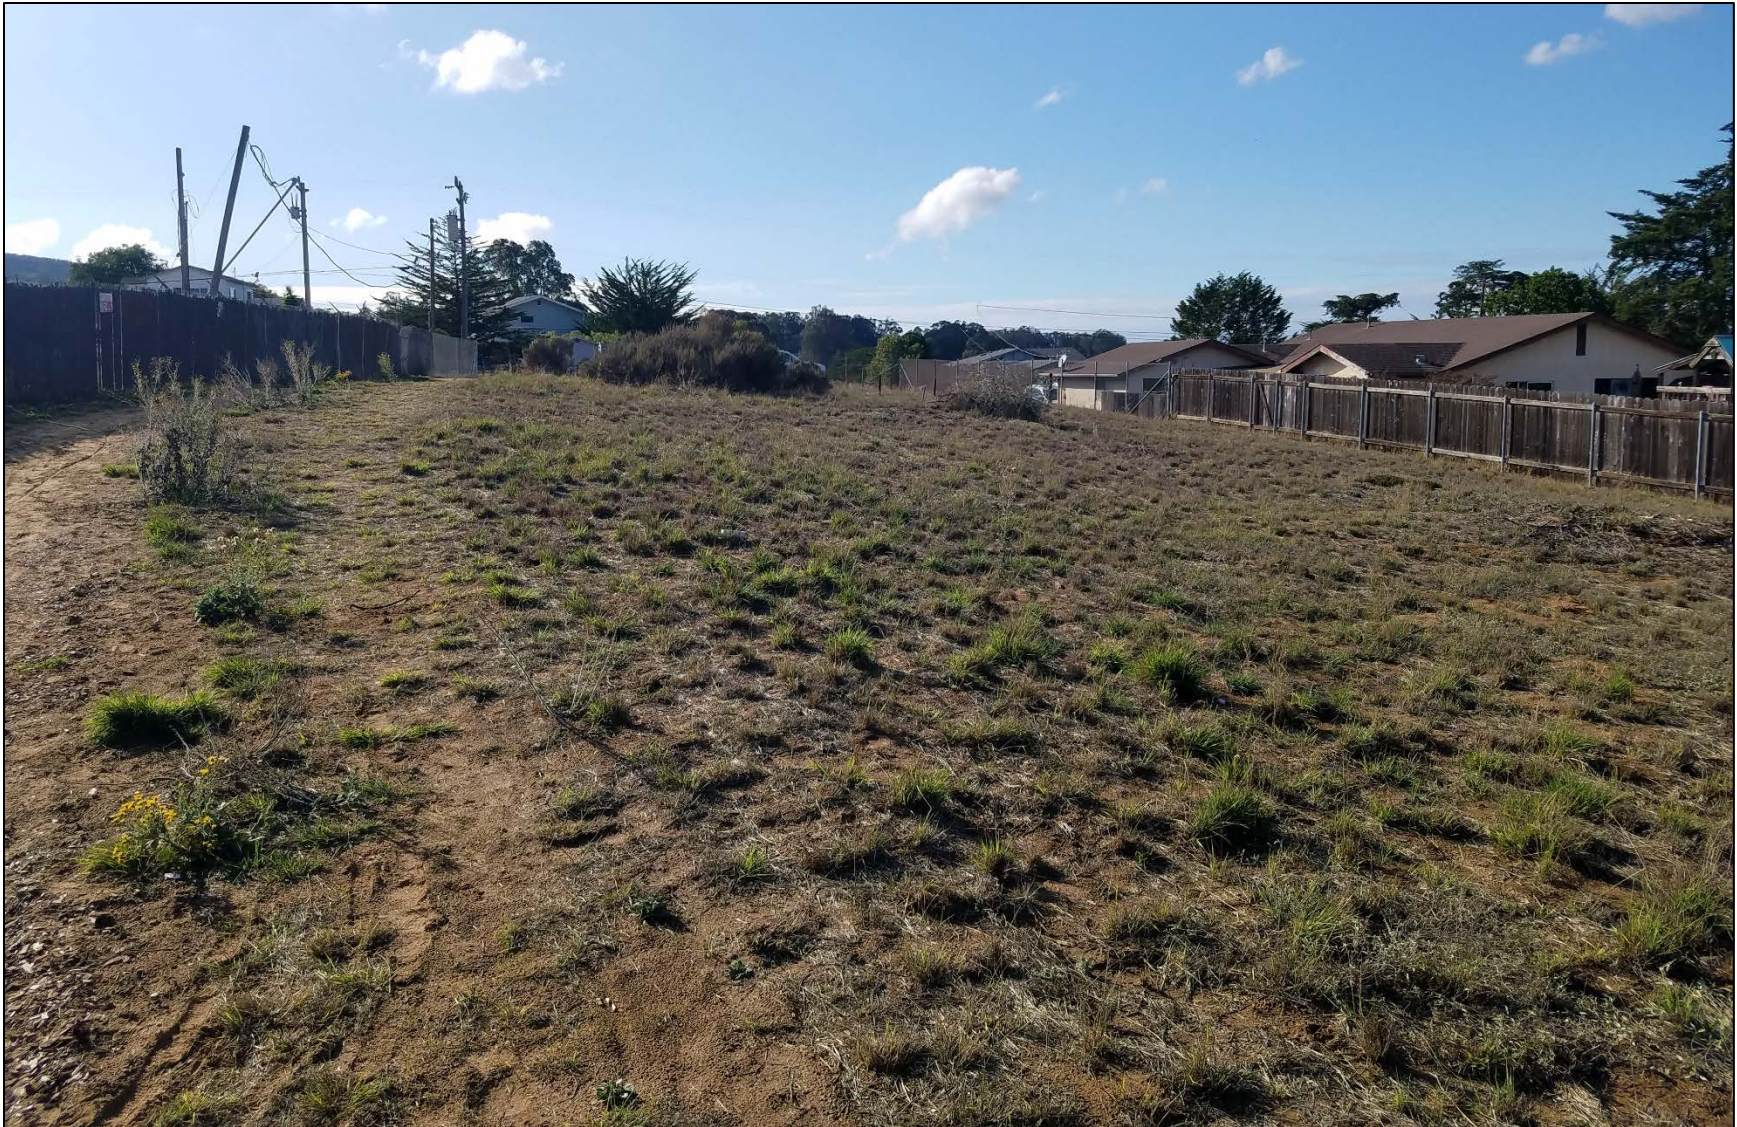
**Photo 2:** Photo viewing west from eastern property line toward Ferrell Street.

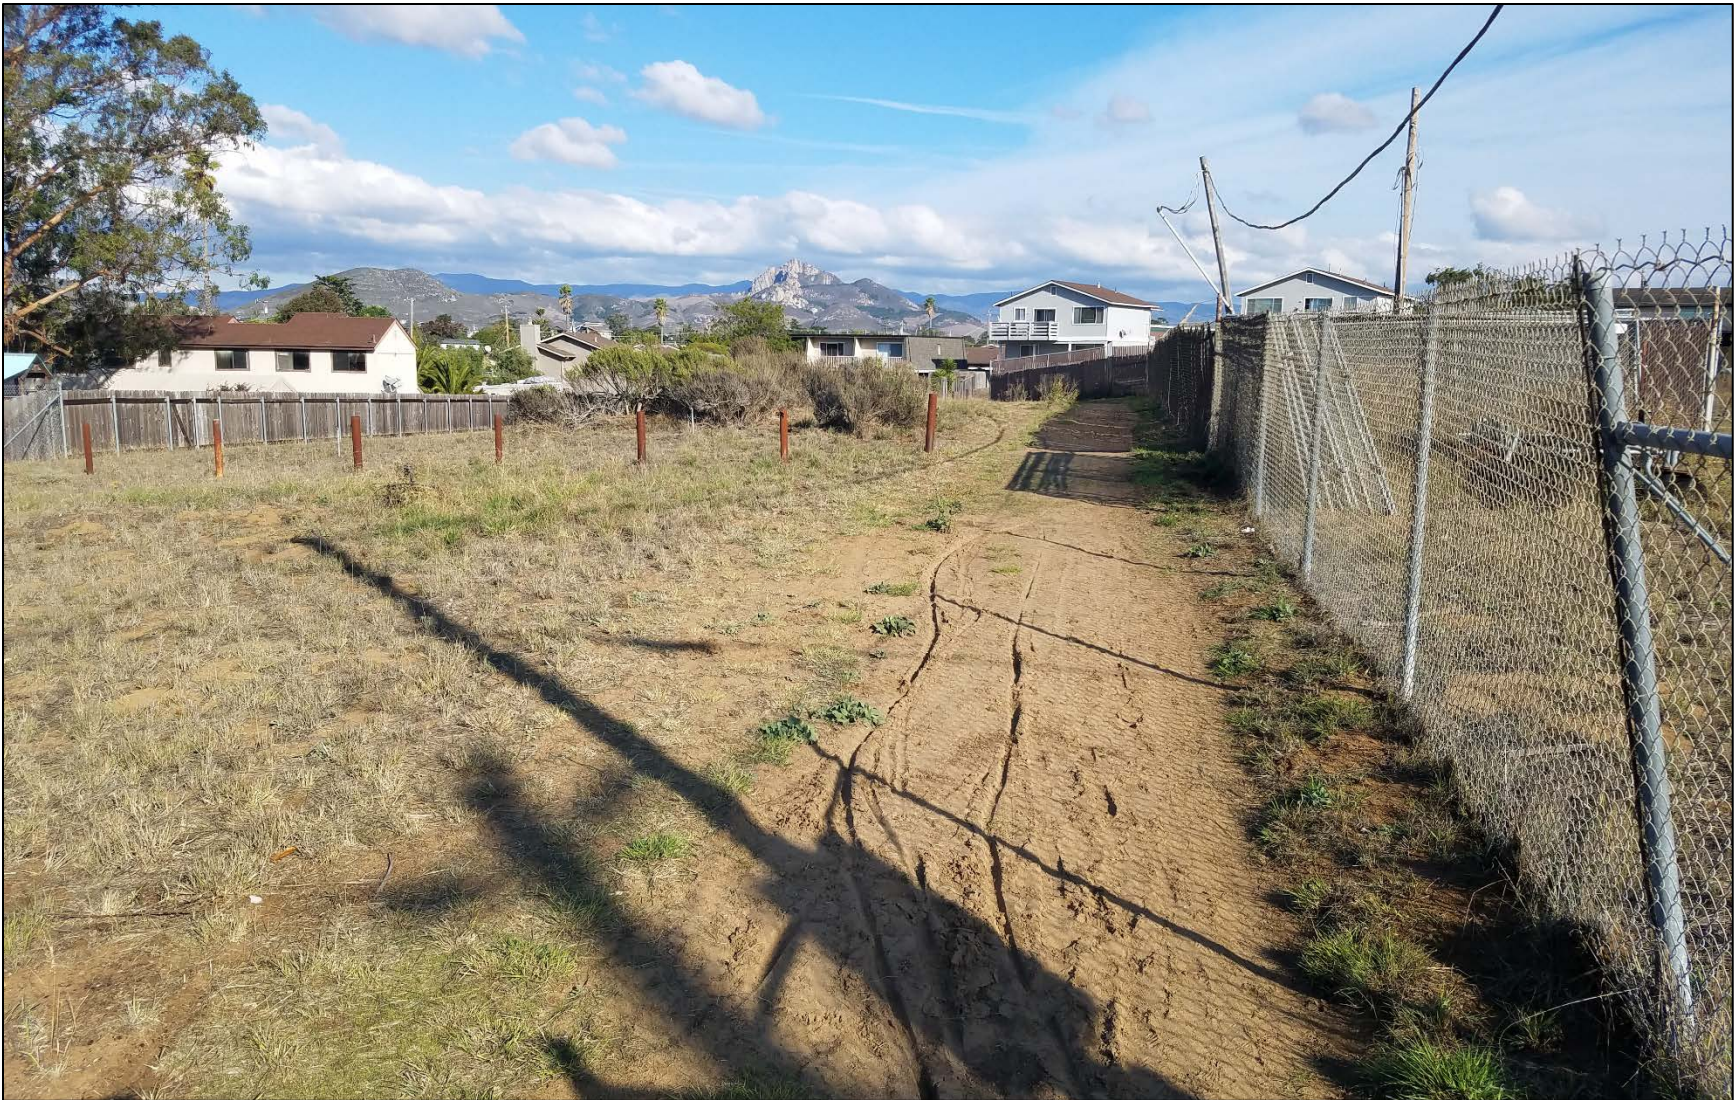
**Photo 3:** Photo viewing east down existing footpath toward the 7<sup>th</sup> Street terminus.

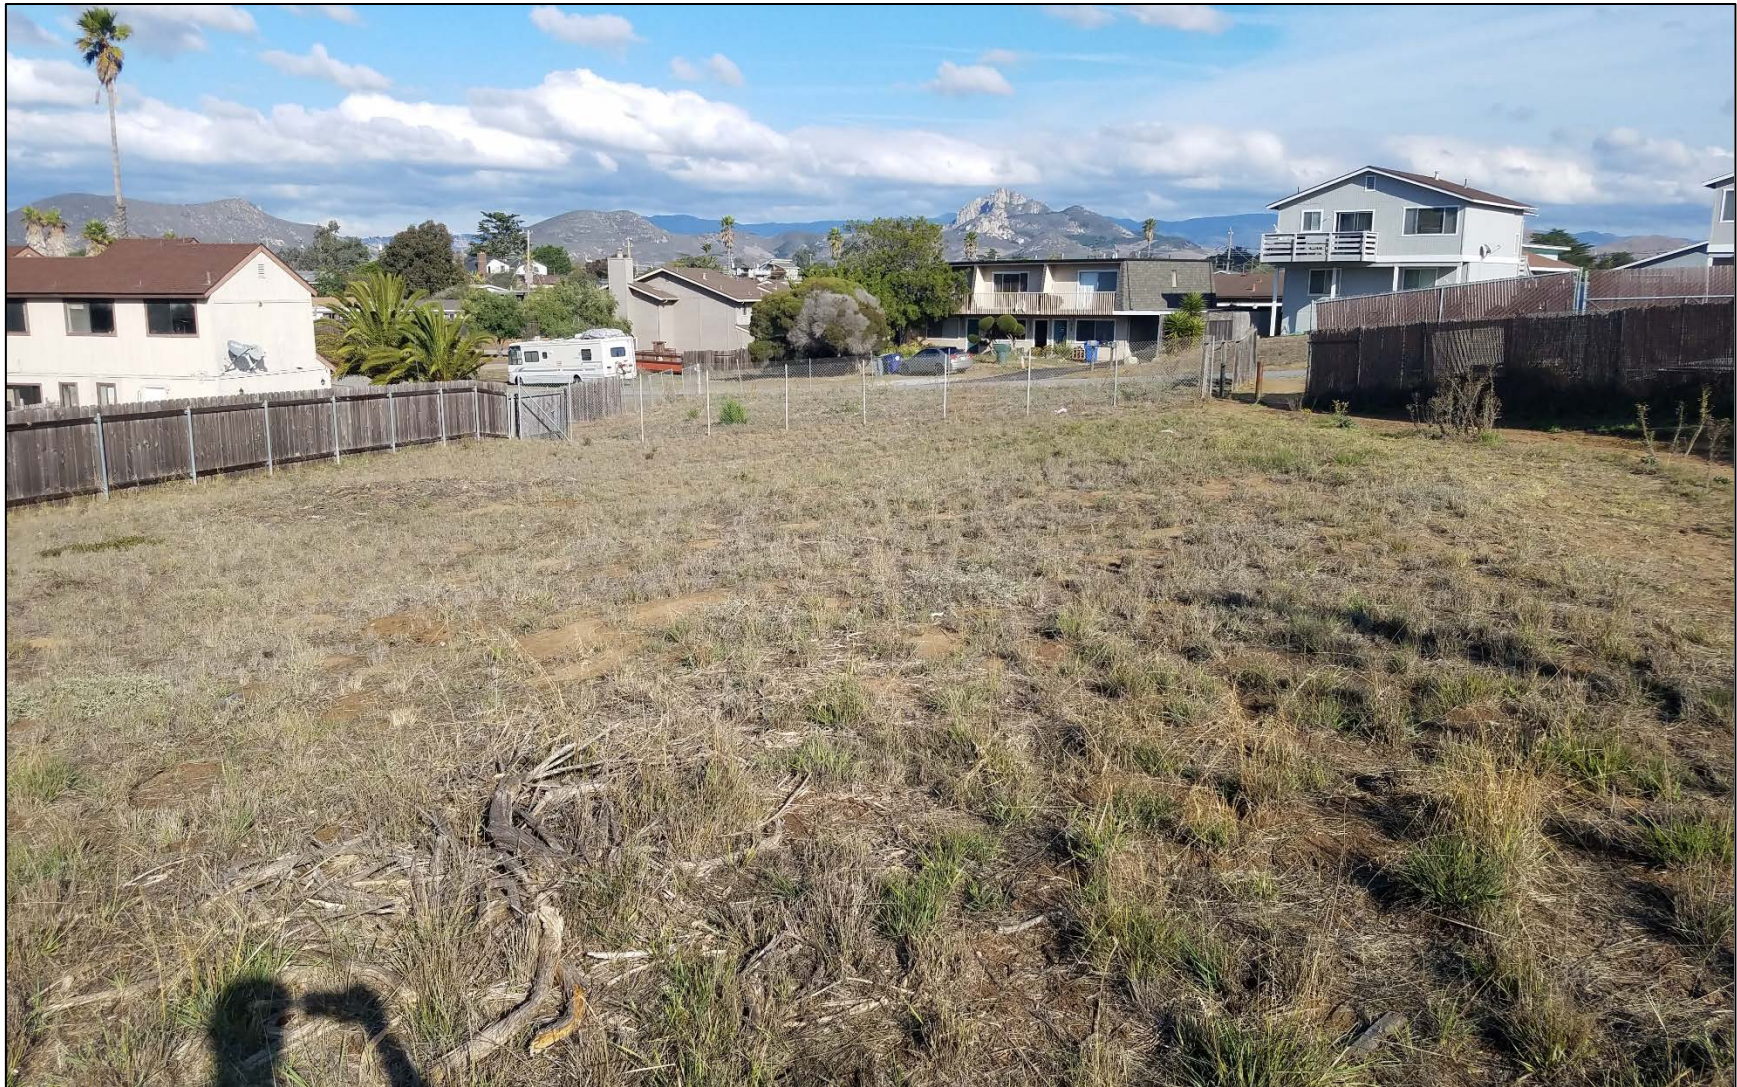
**Photo 4:** Photo viewing east from center of parcel toward the 7<sup>th</sup> Street terminus.

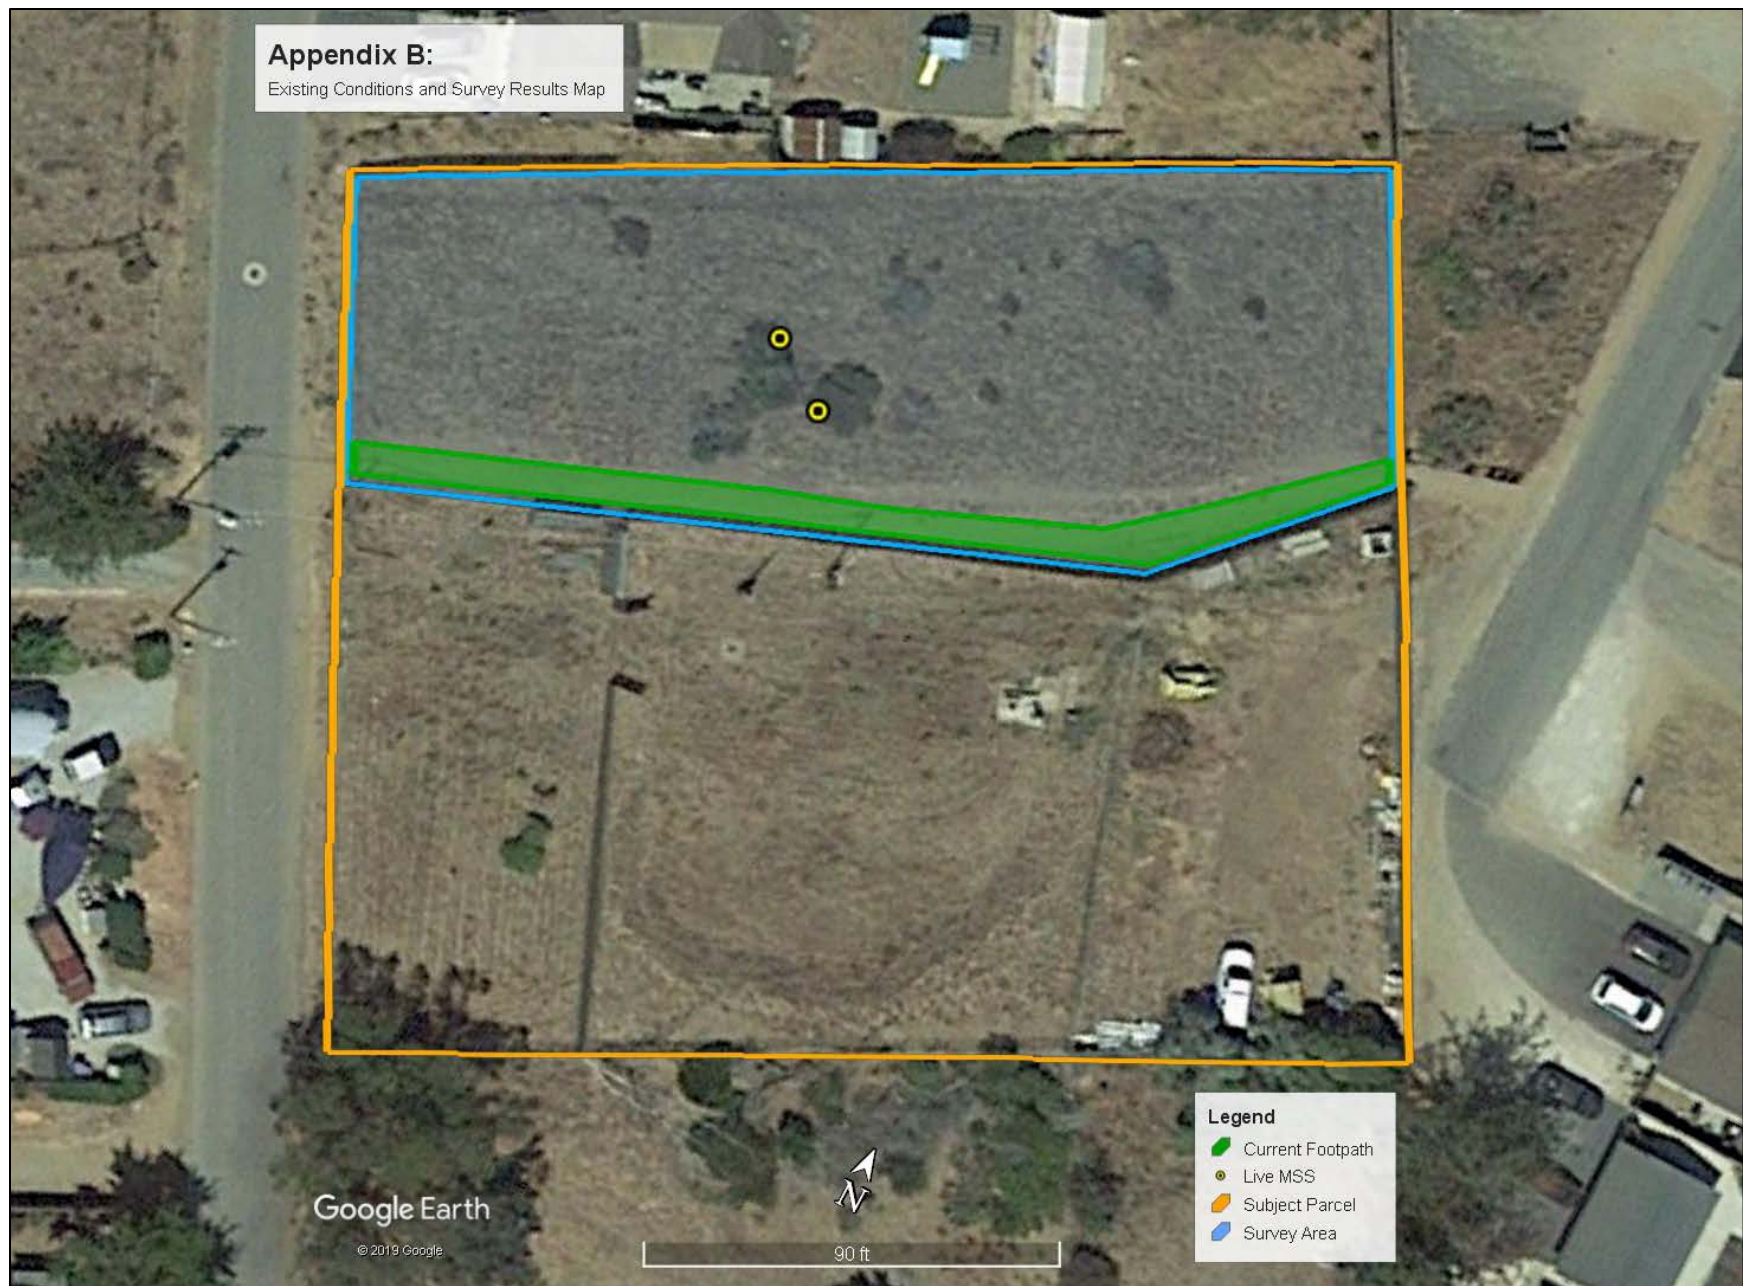
## **Appendix B: Existing Conditions and Survey Results Map**

The 0.4-acre survey area was observed to be disturbed from annual mowing of the area for fire hazard abatement, public use as a footpath between Ferrell Street and 7<sup>th</sup> Street, and as a non-designated "dog park." The survey area was dominated by veldt grass with small isolated stands of coastal scrub species dominated by coyote brush (*Baccharis pilularis*) and black sage (*Salvia mellifera*). The survey area is surrounded by Ferrell Street to the west, an existing single-family residence to the north, a small disturbed vacant parcel and 7<sup>th</sup> Street to the east, and to the south is the remaining portion of the subject parcel that is used by the LOCSD as a storage yard. The adjacent parcels are dominated by disturbed areas that are vegetated with nonnative species. No large areas of native habitats suitable for MSS is contiguous with the survey area. Appendix A includes four (4) site photos taken during the survey and Appendix B includes an aerial of the survey area and subject parcel.
