SUBJECT: Agenda Item 111 – 6/6/2019 Board Meeting
Approve a Snail Study to Determine the Feasibility of a
Pocket Park at the Ferrell Avenue Property

**Ferrell Avenue Well Site
Los Osos, California**

**MORRO SHOULDERBAND SNAIL
PROTOCOL SURVEY REPORT**

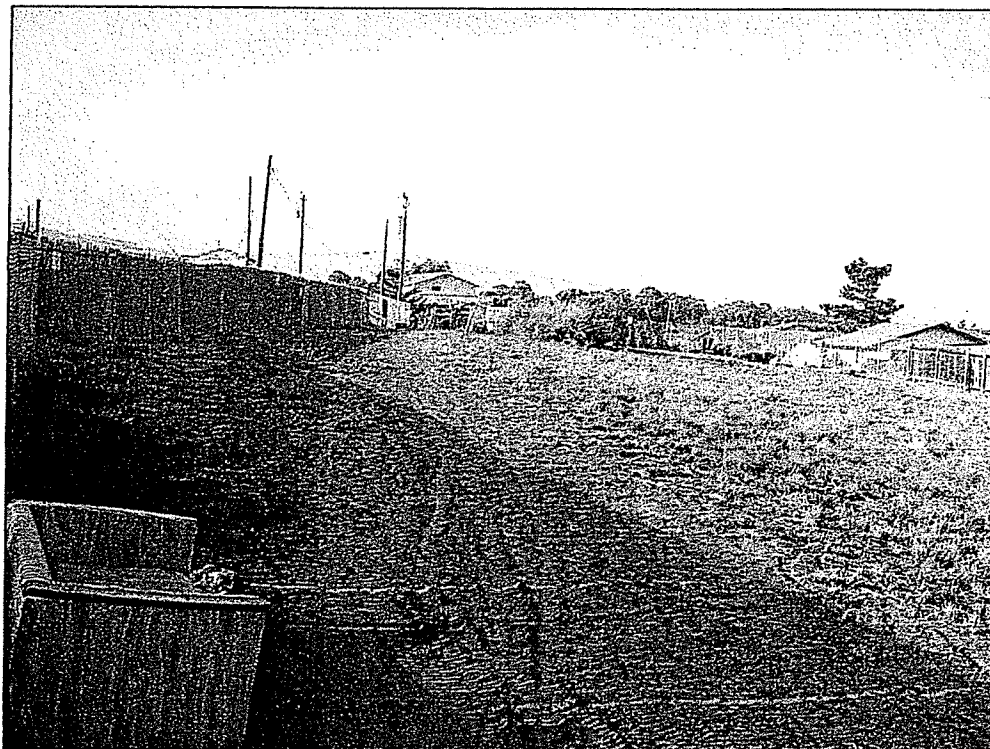
Photo 4:

View of adjacent area, including community garden plots, looking west. This area provides a connection between Ferrell Avenue and 7th Street, and receives significant foot and bicycle traffic. Picture taken December 12, 2006.
