SUBJECT: Agenda Item 2A – 04/06/2022 Board Meeting
Station 15 Building Condition Assessment Final Report

**LOS OSOS COMMUNITY SERVICES DISTRICT
FIRE STATION 15
CONDITIONS ASSESSMENT**

The Los Osos Community Services District sought to obtain a building condition assessment report for the District's Fire Station No. 15 to determine the physical adequacy of the primary facility in the short term and long term future, and recommendations for improvement over a 10 year period of time.

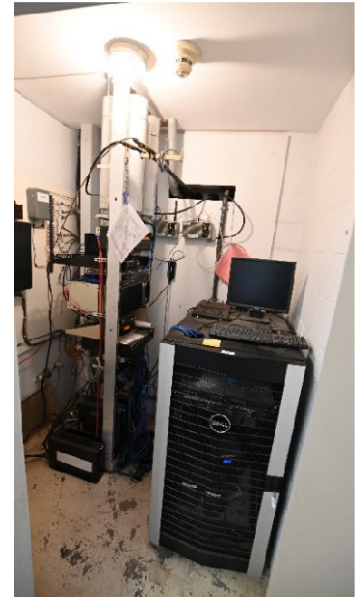
Existing Radio Room

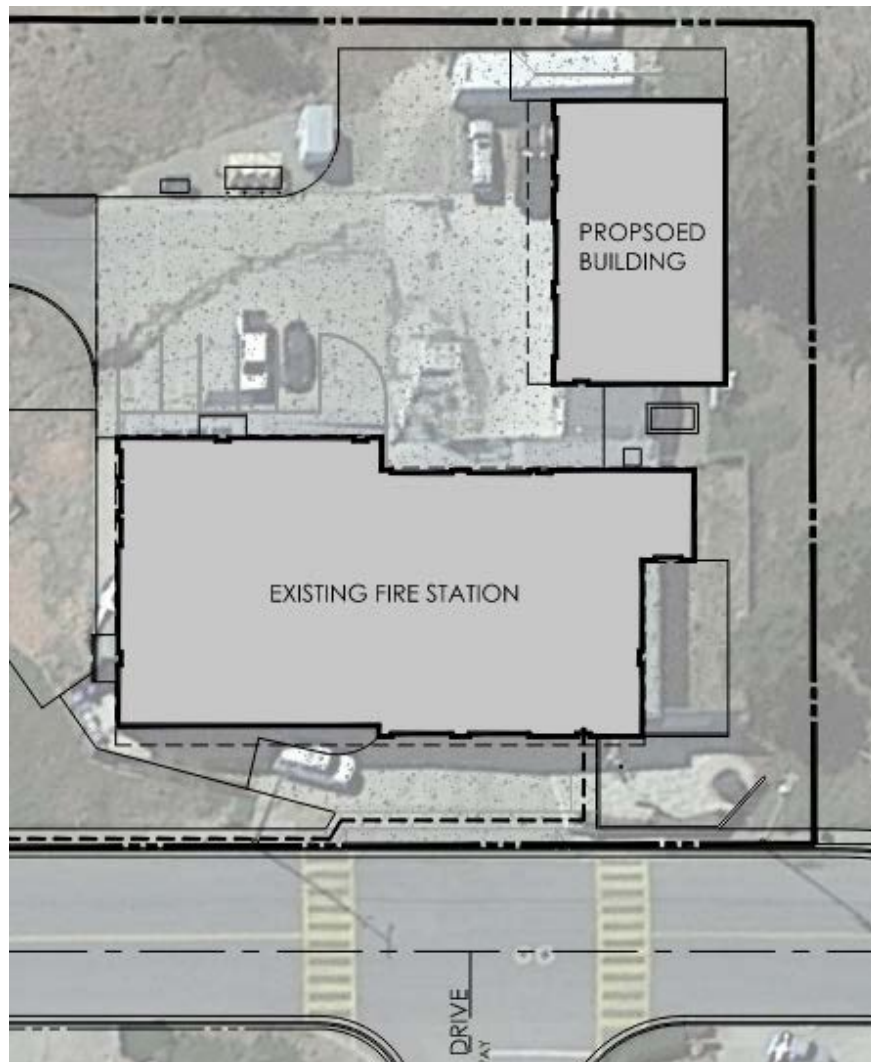
Figure 4: Proposed Site Plan w/new Apparatus Building

The following narratives reflect the options identified to remodel the existing building and construct a new apparatus bay at the rear of the property as identified in the figures below.

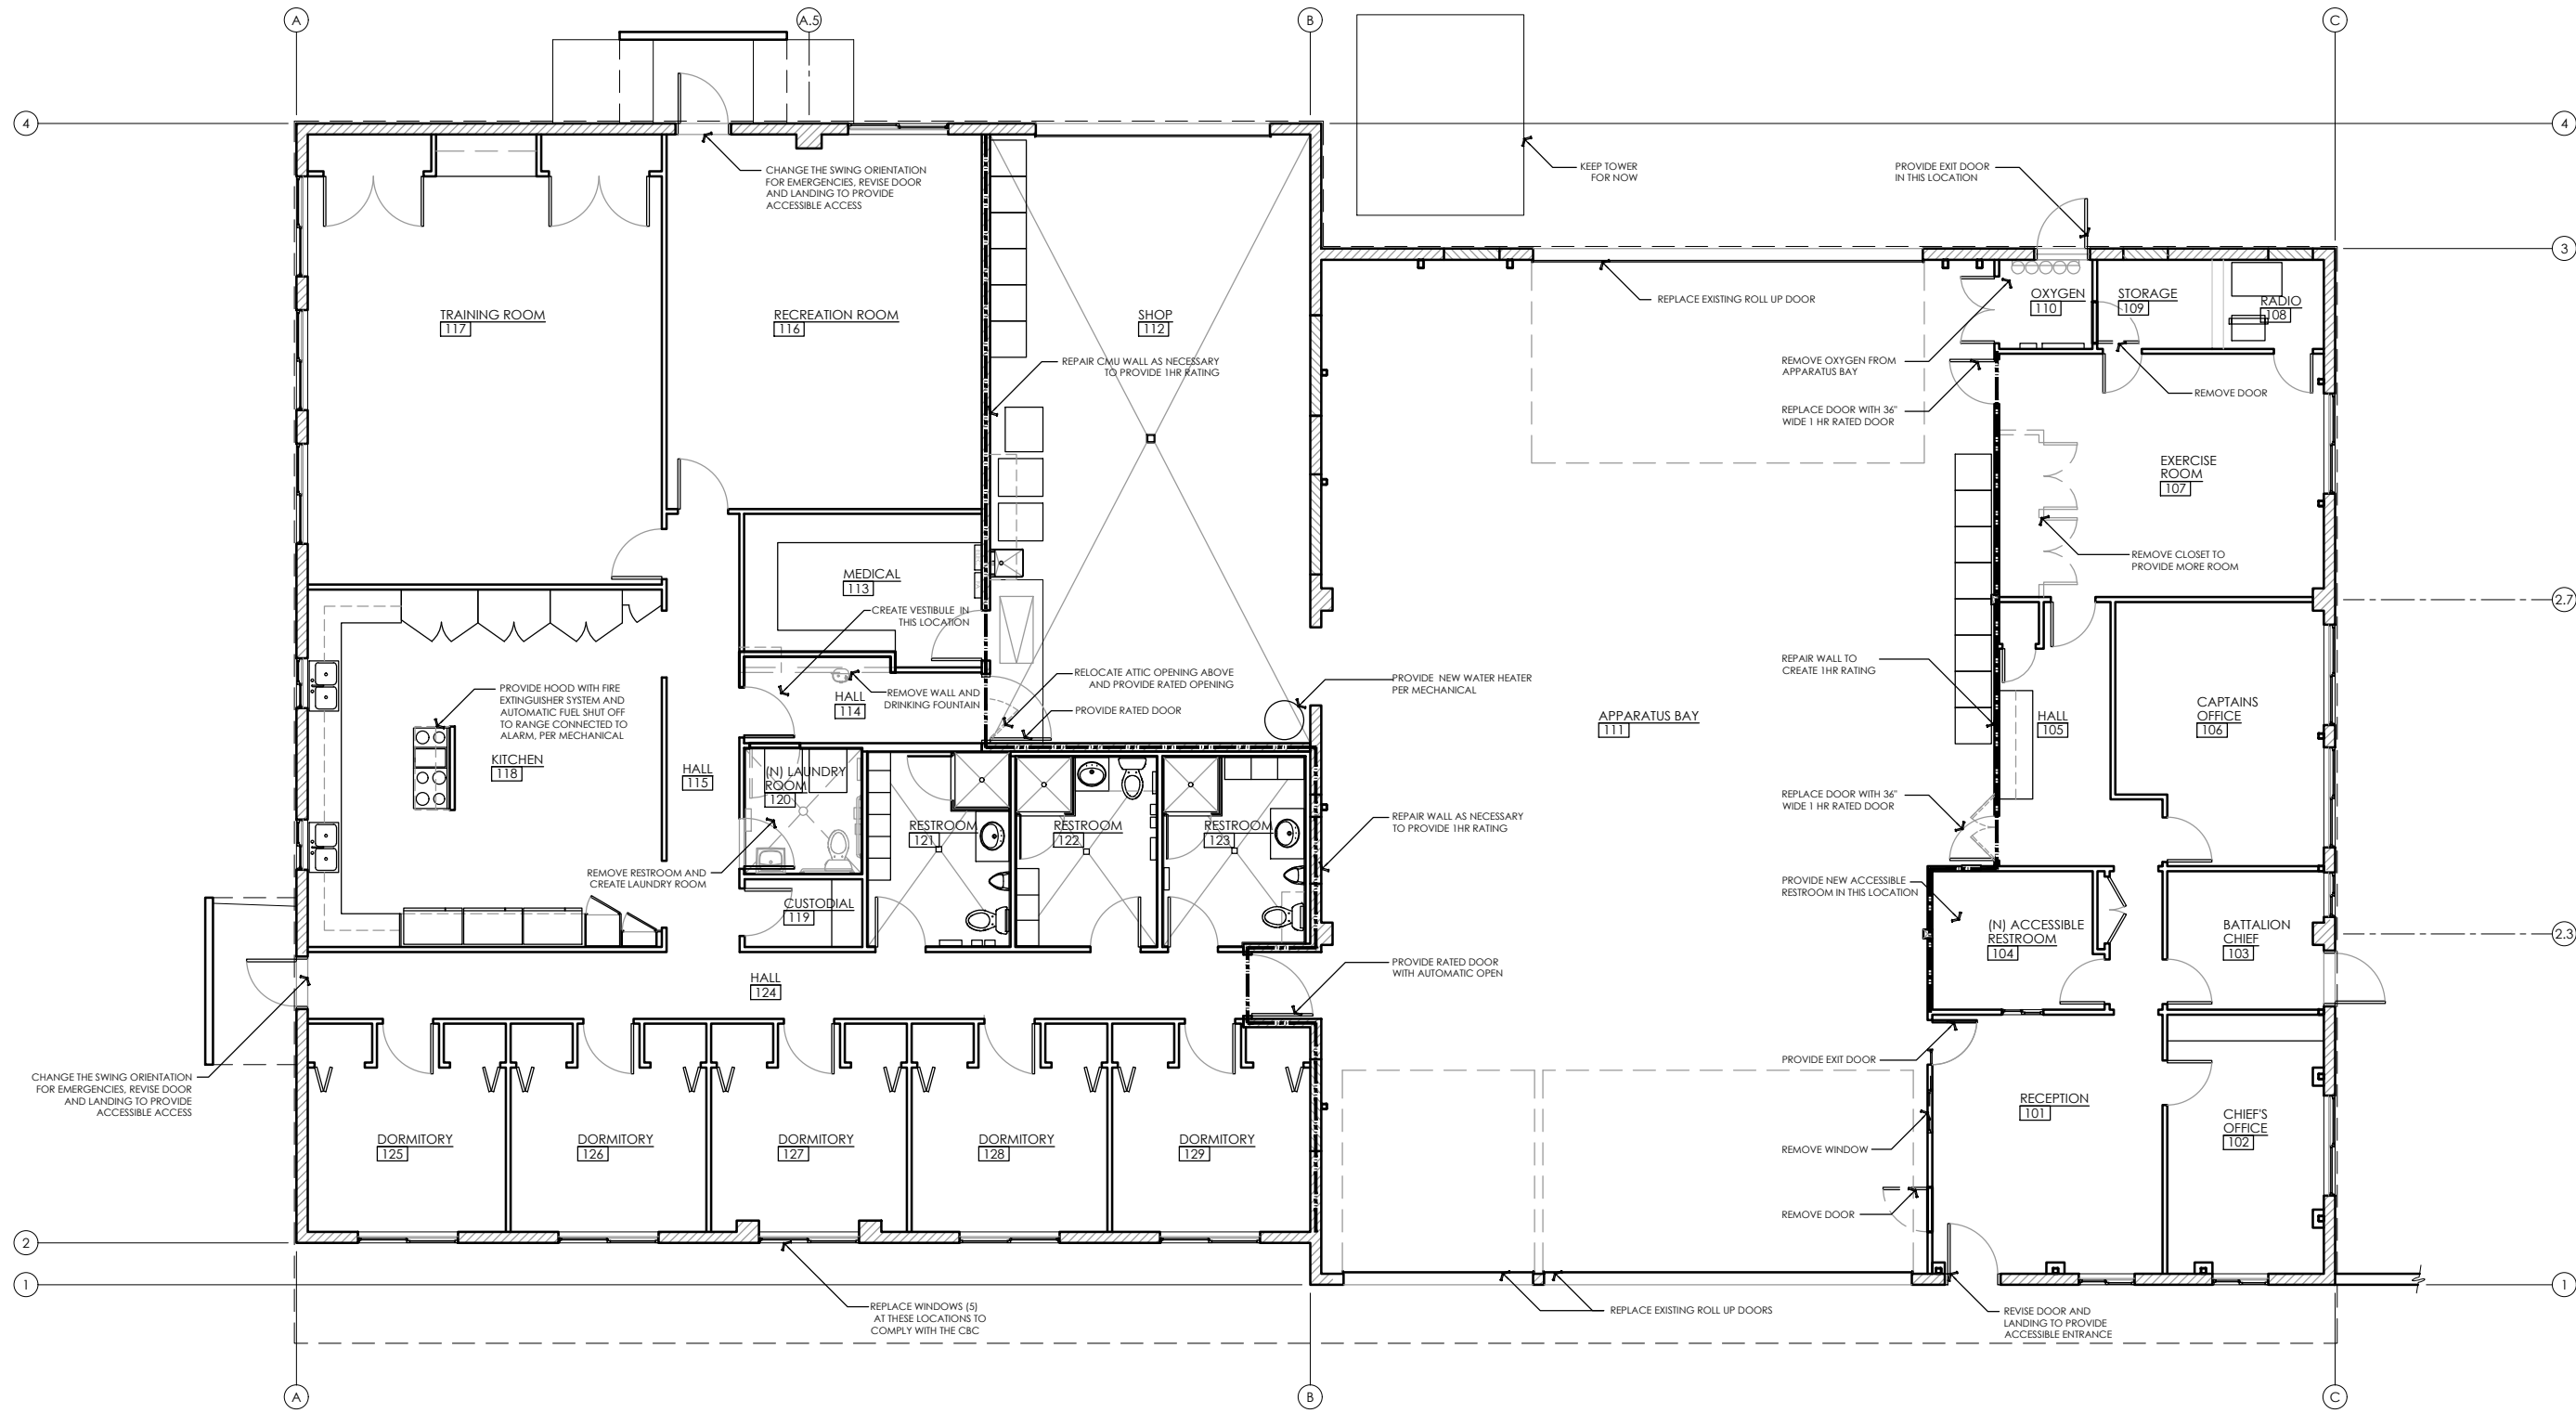
EXISTING FLOOR PLAN WITH HIGH PRIORITY IMPROVEMENTS

1. Make improvements to the existing Fire Station within the existing building footprint to correct high priority deficiencies in the short term. (Refer to Sheets A2.0 "Existing Floor Plan", S2.0 " Foundation Plan, Minimum Seismic Retrofit" and S2.1 "Roof Framing Plan, Minimum Seismic Retrofit"
2. Remodel the existing Fire Station to enhance the overall Life/Safety, operations, accessibility, and to bring the Fire Station up to current building codes. This can happen over several budget cycles (Refer to Sheets A1.0 "Proposed Site Plan", A2.1 "Proposed Floor Plan, A3.0 "Proposed Floor Plan", A3.1 "Proposed Floor Plan "Auxiliary Apparatus Bay", S3.0 "Foundation Plan, Addition/Remodel Option, S3.1 Roof Framing Plan, Addition/Remodel Option, and S4.0 "New Building Foundation and Roof Framing Plan".
